## WET INSULATION MEETS ITS MATCH

Re: Scheman Building Moisture Survey Results

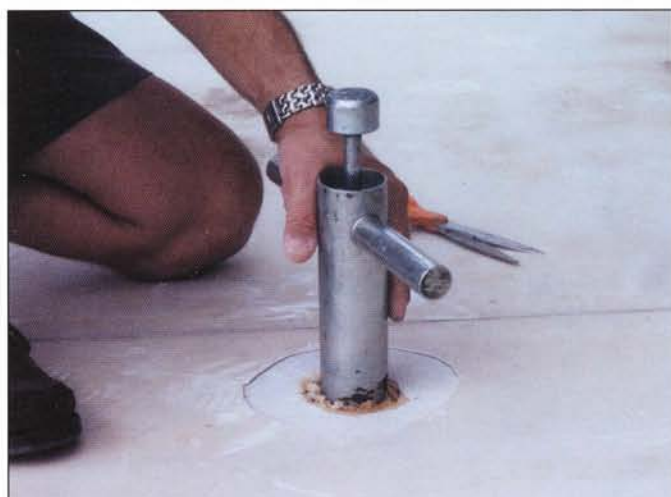
Core cuts were made in two of the previously identified wet areas.

As *Roofing Contractor* reported two years ago, the job to reroof the Scheman Center was relatively straightforward and went off without a hitch. In July 2002, about 20 months after the work was completed, Chuck Beyer of Beyer Roofing Sales, 2001 Company's local representative, requested that core cuts be made in two of the previously identified wet roof areas.

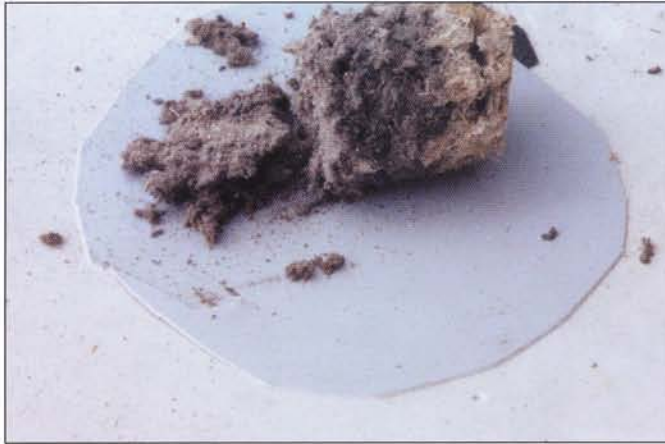
Core cuts show dry insulation.

the insulation was completely dry."

The insulation consisted of 1.1/2" of perlite and 1/2" wood fiberboard directly below a Hypalon membrane. The vapor barrier appeared to be a modified asphalt membrane consistent with a modified base sheet. Upon observation and as can be seen in the enclosed photographs, the insulation was completely dry.

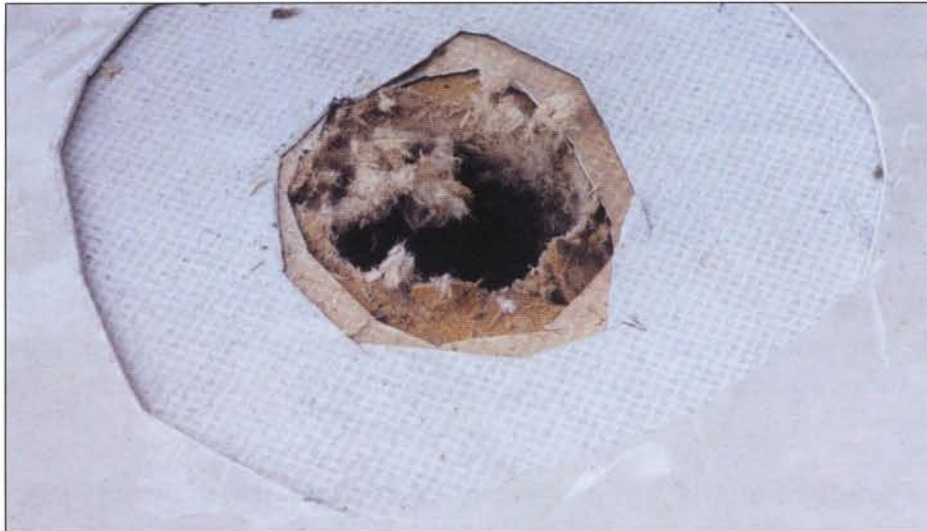
Cuts were made through the new membrane, existing Hypalon membrane and insulation, down to the vapor barrier.

In July of 2002, at the request of Chuck Beyer, Beyer Roofing Sales, 2001 Company area representative, core cuts were made in two of the previously identified wet roof areas. Cuts were made through the new membrane, existing Hypalon membrane, and insulation down to the vapor barrier over the existing deck.

Considering the location of the vapor barrier over the existing deck below the insulation the drying out of the wet insulation could only have happened upward and be directly contributed to the 2001 system.
