2001 Co. Severe Hail Damage Testing

Koontz Associates Engineering Hobbs New Mexico
An Air Gun Shoots 1", 2", or 3" Hail Balls at a roofing

Membrane
And substrait
chilled to
36° to 40°F
At 60 mph
90 mph
120 mph
150 mph

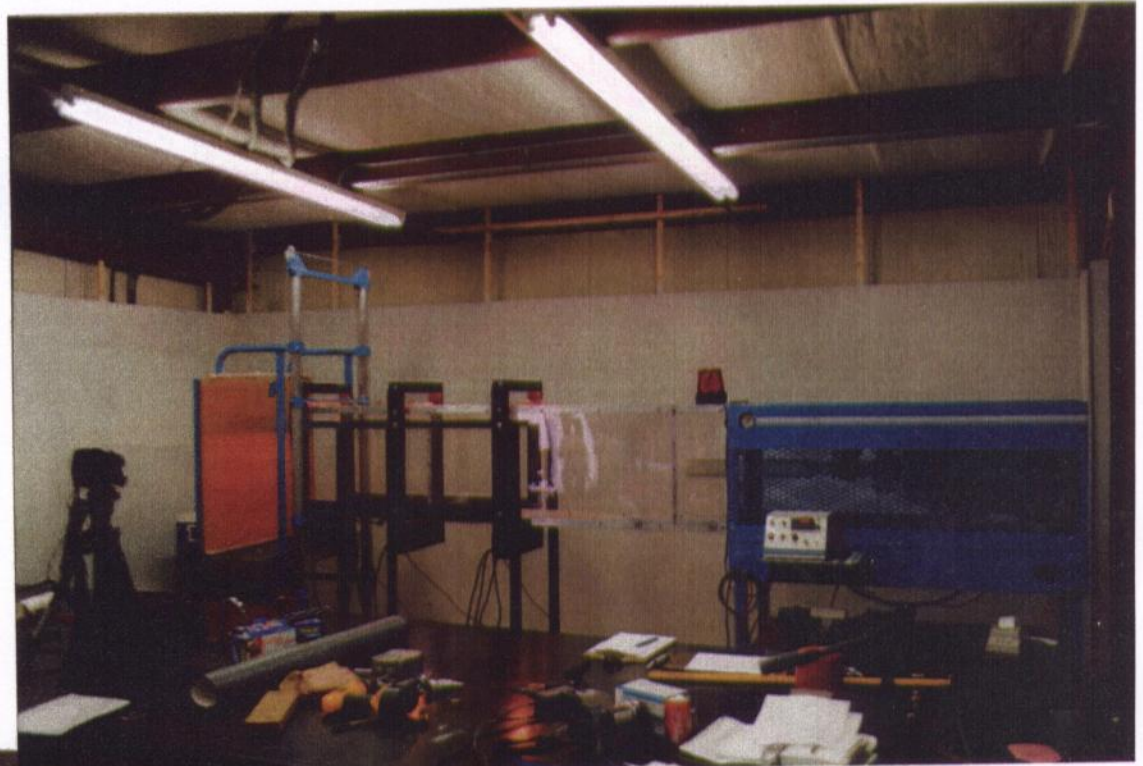
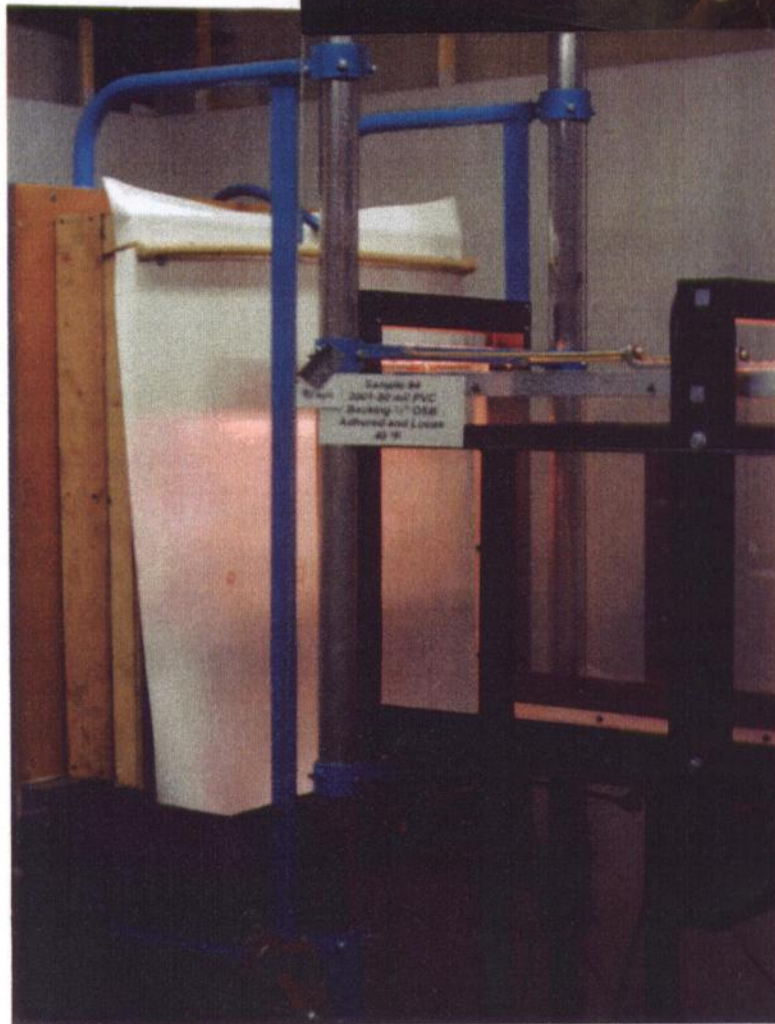
The Koontz engineering hail gun shoots various sizes hail balls at a cooled **38°F** roof assembly surface

An air cannon above shoots a hail ball through a 10" speed recording chamber at a roof surface

Notice how the PVC roof membrane is cooled with a spray of **38°F** water.

The hail impact area is forensically examined for damage and the results are reported accordingly.

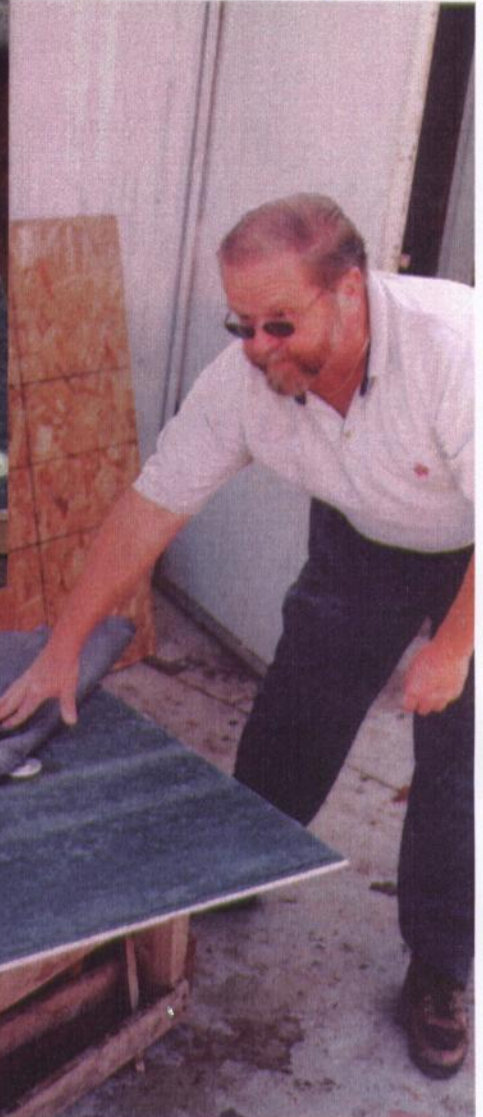
Above 3" Hail at 90 to 120 mph
On loose 1/2 Dens Deck over
2" ISO with 90 mill plus C-EPDM

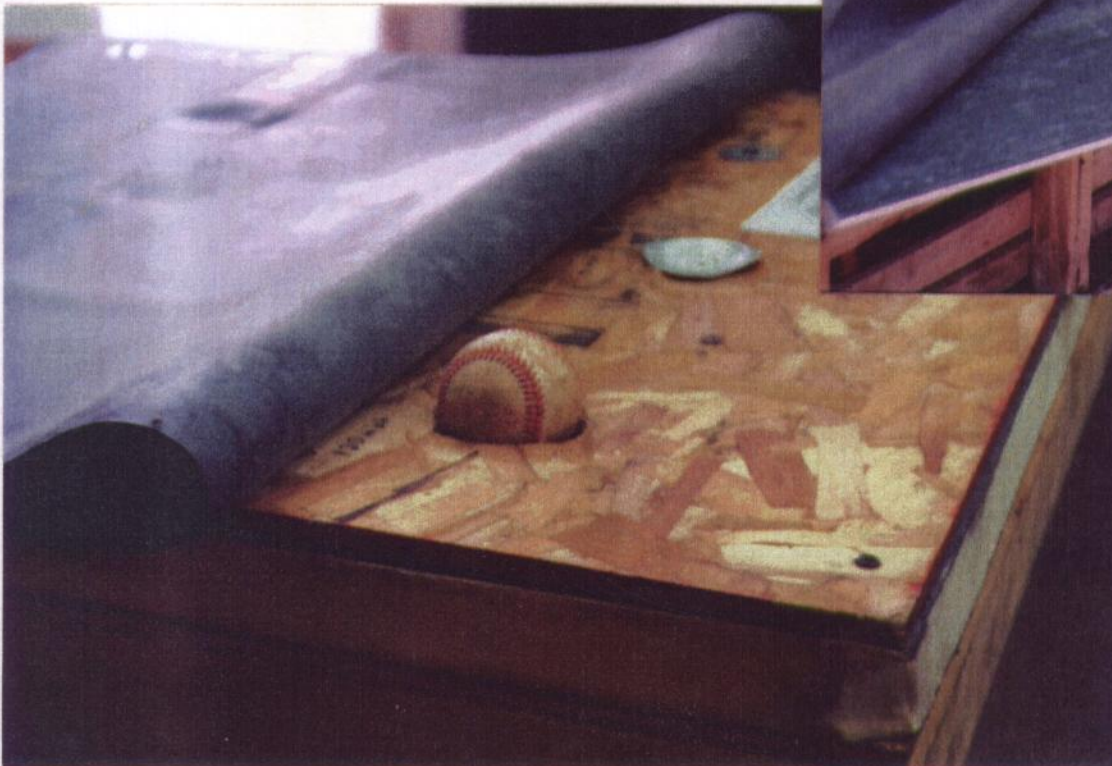
Notice 3" hail
impact into
1/2 " OSB water
board at 120
miles per hour
No C-EPDM
Damage.

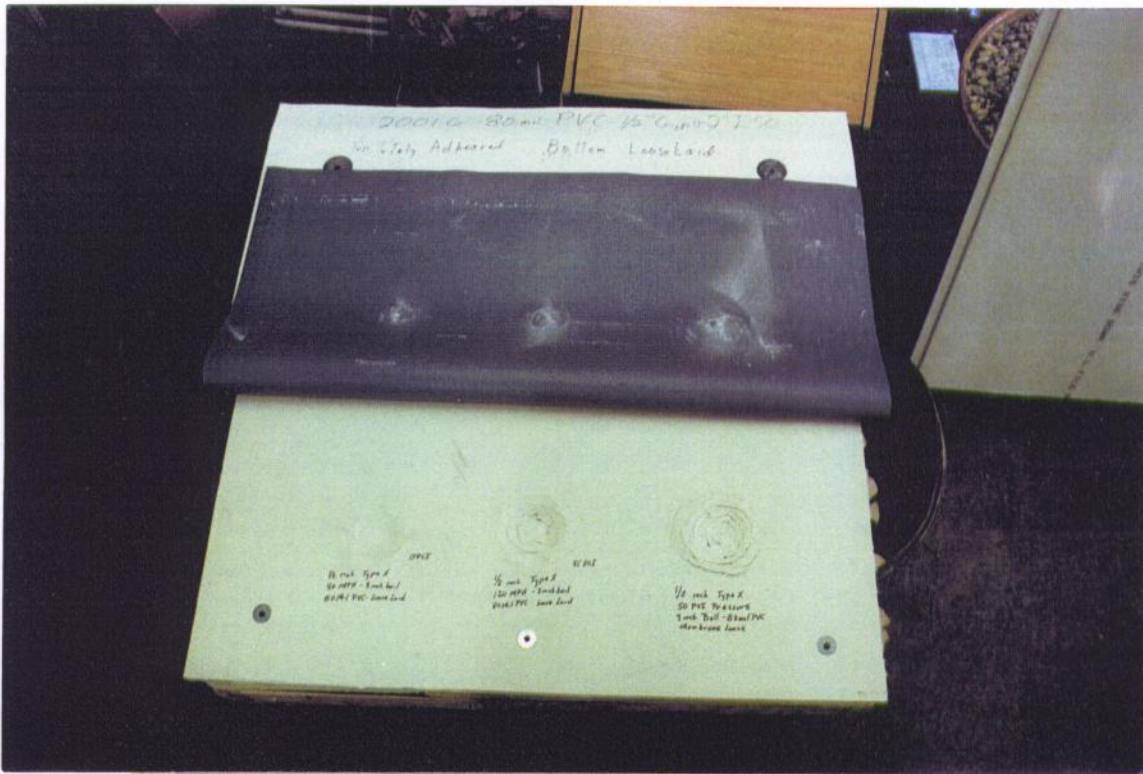
80 mill Reinforced PVC over 1/2 " Gypsum

90 mph
120 mph
150 mph
Miles per
Hour

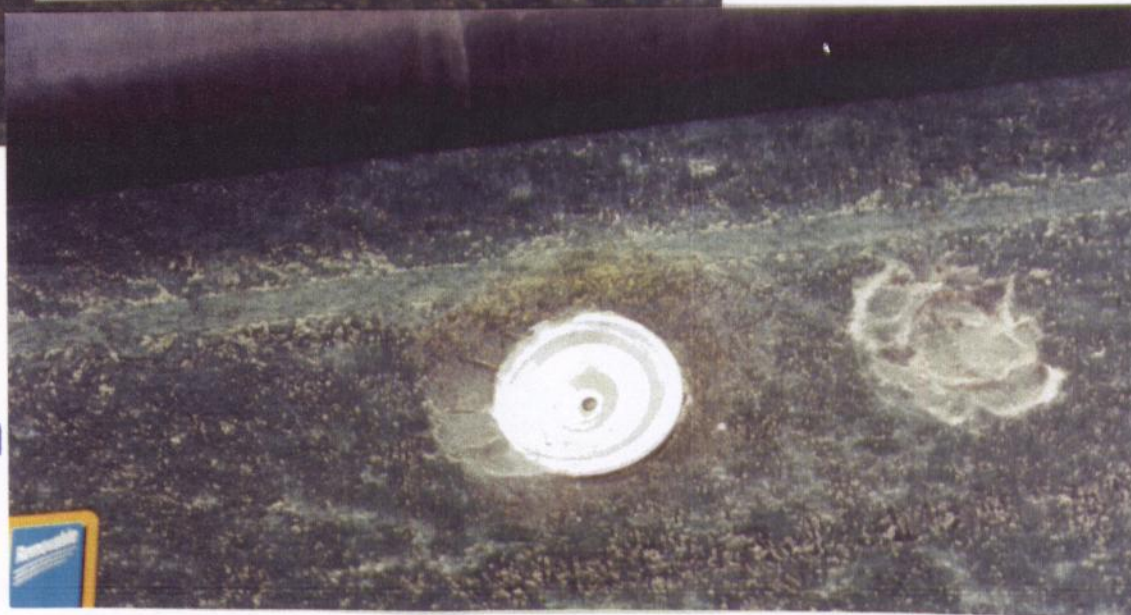
C-EPDM 90mil Plus on Deck
Sample # 2
40°F

3" Hail
Shot at
120mph

C- EPDM
90 Mil +
1/2" Gypsum
2" ISO
